Sample Marine Survey Report
1989 Thompson 288 in winter trim
Prepared for xxxxx

GENERAL INFORMATION

SCOPE OF SURVEY Acting at the request of xxxx, the surveyor did attend onboard the Thompson 288 on May 25 2010 at xxxx Marina, Ontario, where an out of water inspection including the underwater machinery and the exterior of the hulls wetted surface was performed.

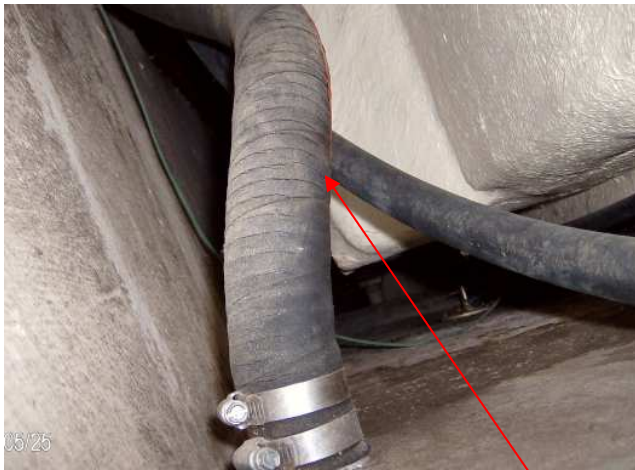
- (1) Fuel supply lines from the tanks to the engines are weather deteriorated
- (2) Fuel fill hose, starboard side is weather deteriorated; port side could not be seen

A1 fuel fill hose starboard side weather deteriorated (cracks)

FINDINGS	RECOMMENDATIONS
A1 (1) Fuel supply lines from the tanks to the engines are weather deteriorated <i>"Hoses shall be USCG Type A1-15 ABYC H24</i> (2) Fuel fill hose, starboard side is weather deteriorated; port side could not be seen <i>"Flexible fuel fill hose installed in the engine compartments shall be USCG Type A1, A2, or A1-15" ABYC H24</i>	Replace with fuel line per ABYC recommendations.
A2 TC safety equipment	Obtain missing TC safety equipment before commissioning the vessel for use.

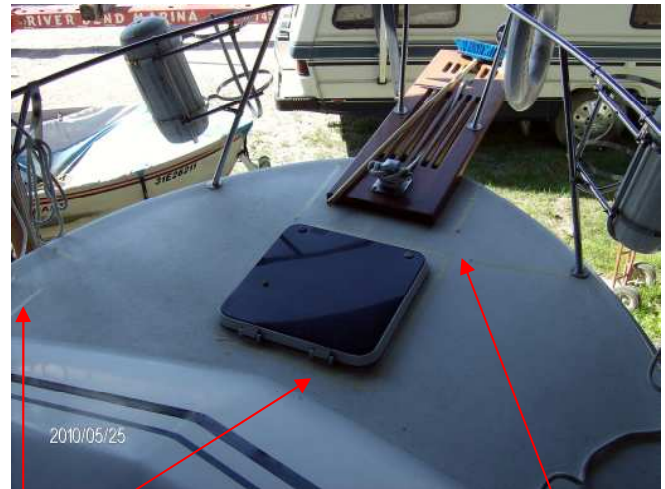
Elevated moisture meter readings where tested at random suggest water intrusion at;
Transom; above the engine space drain plug, approximately 6" high x 12" wide

Percussive soundings where tested at random suggest delamination at;
Transom; above the port side trim tab hydraulic actuator, below the second from the port side swim platform support, inboard of the starboard side trim tab hydraulic actuator and above the engine space drain plug

Elevated moisture meter readings where tested at random suggest water intrusion at; Fore deck; fore, aft and starboard side of the v berth hatch, port side near stanchion five as counted from the bow, both sides of the anchor platform and starboard side near stanchion three as counted from the bow

B1 Areas mentioned are taped

<p>B1 Elevated moisture meter readings where tested at random suggest water intrusion at; Transom; above the engine space drain plug, approximately 6" high x 12" wide</p> <p>Fore deck; fore, aft and starboard side of the v berth hatch, port side near stanchion five as counted from the bow, both sides of the anchor platform and starboard side near stanchion three as counted from the bow.</p> <p>Percussive soundings where tested at random suggest delamination at; Transom; above the port side trim tab hydraulic actuator, below the second from the port side swim platform support, inboard of the starboard side trim tab hydraulic actuator and above the engine space drain plug</p> <p>The bridge; aft of the helm seat, approximately 6" x 24". Starboard side of the v berth hatch. On the side deck, stanchion five, port side, as counted from the bow. On the cockpit sole aft of the bridge access ladder, outer mount, approximately 6" wide x 24" long</p>	<p>Remove all fasteners and hardware, reseal and mount securely to stop any further water intrusion. Repairs may be required in the future.</p>

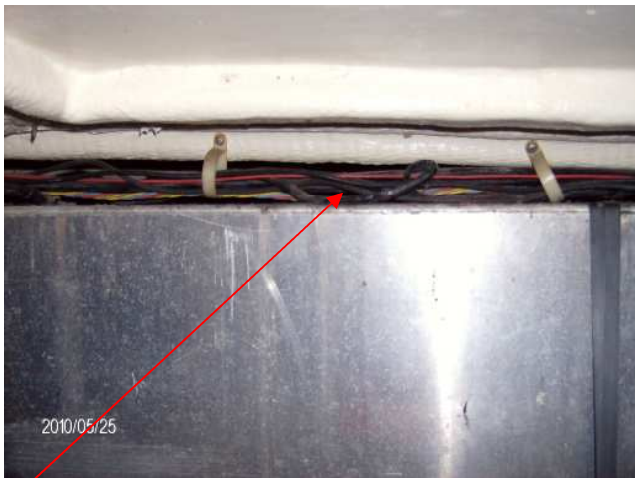
- (1) Starboard side battery has exposed positive post
- (2) 12 volt DC wiring is lying on top of, in contact with, the starboard side fuel tank

B4 12 volt DC wiring laying on top the fuel tank

<p>B2 No blower warning plaque at the lower helm seen <i>"A blower instruction placard shall be provided at every ignition switch indicating the length of blower operating time is required to clear the engine space prior to starting the engine (four minutes)"</i> TC / TP1332</p>	<p>Install a blower warning plaque per TC.</p>
<p>B3 Both sea water supply hoses from the ball valves to the engine are weather deteriorated</p>	<p>Replace hoses.</p>
<p>B4 (1) Starboard side battery has exposed positive post <i>"Each battery shall be protected so that metallic objects cannot come in contact with the ungrounded terminal."</i> ABYC E10 (2) 12 volt DC wiring is lying on top of, in contact with, the starboard side fuel tank</p>	<p>(1) Cover battery post or install in a battery box with cover.</p> <p>(2) Relocate 12 volt DC wiring as required.</p>

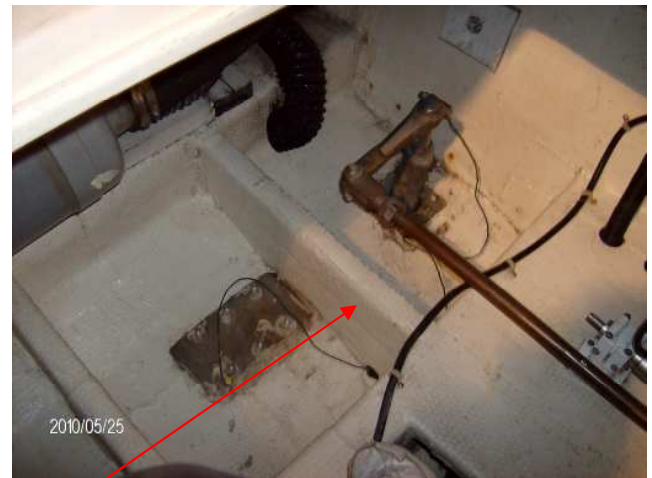
Percussive soundings where tested at random suggest delamination at;
Hull stiffener, starboard side ahead of the rudder post

C2 Delamination suggested here
Bilge is free of oil contamination

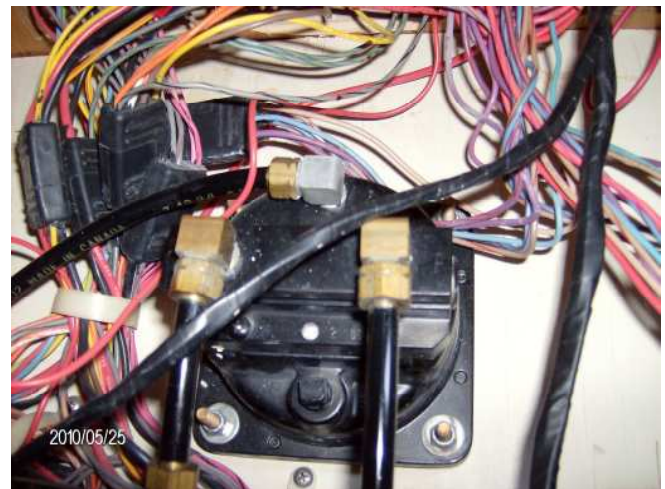
Tidy 12 volt DC wiring, lower helm
