Sample Marine Survey Report
1989 Aloha 30 sloop
Prepared for xxxx

John Bond Marine Surveyor SAMS®AMS®
Accredited Marine Surveyor Pre-purchase and Insurance Marine Surveys

SCOPE OF SURVEY Acting at the request of xxxx, the surveyor did attend onboard the Aloha 30 on May 21 2011 in xxxx Ontario, where an out of water inspection including the underwater machinery and the exterior of the hulls wetted surface was performed.

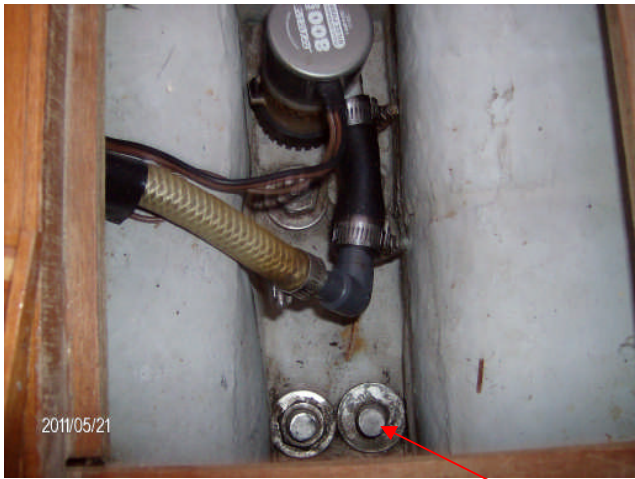
- (1) Keel bolt fastener is missing
- (2) Signs of water leaking at the hull to keel joint

B1/1 keel bolt missing

FINDINGS	RECOMMENDATIONS
A1 TC safety equipment	Obtain missing TC safety equipment before first launch.
B1 (1) Keel bolt fastener is missing (2) Signs of water leaking at the hull to keel joint	(1) Replace missing keel bolt (2) Remove existing keel to hull fairing, reseal joint and re torque keel bolts.
B2 Water leak in the quarter berth needs attention, wood is delaminated	Inspect and repair.
B3 (1) Galley sink drain thru hull fitting is loose in the hull (2) Head sink drain hose is disconnected at the sink end	(1) Remove, reseal, and mount securely. (2) Reconnect hose before use.
B4 Port side fresh water tank is not securely mounted	Inspect and repair.

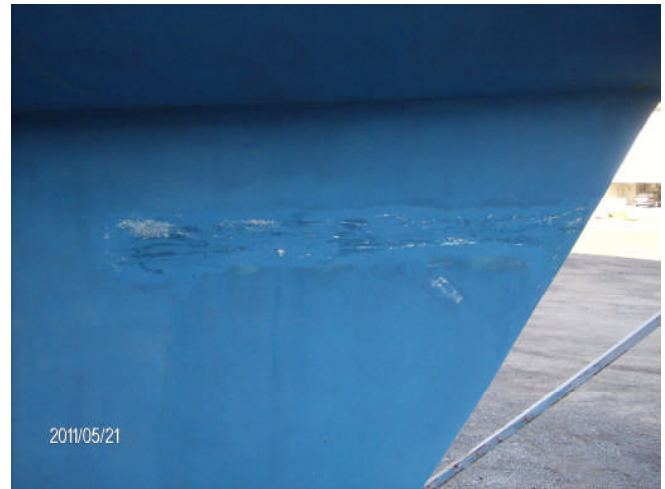
B1 signs of water leaking at the hull to keel joint

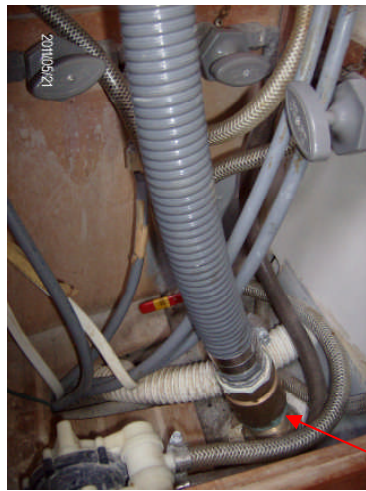
- (1) Galley sink drain thru hull fitting is loose in the hull
- (2) Head sink drain hose is disconnected at the sink end

B3 galley sink drain thru hull fitting is loose in the hull

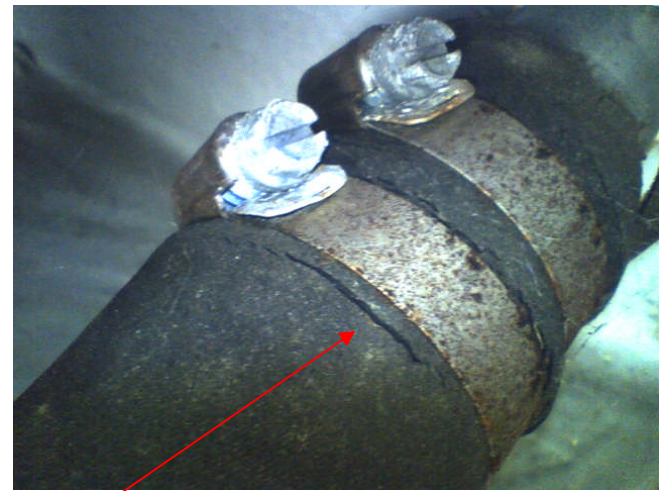
Exhaust hose, at the transom end is deteriorated

B6 exhaust hose deteriorated

<p>B5 Cutlass bearing is visibly loose</p>	<p>Recommend replacing the cutlass bearing.</p>
<p>B6 Exhaust hose, at the transom end is deteriorated</p>	<p>Recommend replacing exhaust hose from the muffler to the outlet end. Use marine grade hose SAE J2006 or UL1129</p>
<p>B7 (1) No fuel shut off valve was seen at the fuel tank <i>“A shut off valve is required at the fuel tank in systems where fuel may siphon, and in gravity feed systems”</i> <i>ABYC H33</i> (2) Fuel supply hose from the water separator to the engine is deteriorated <i>Hoses shall be Type A1 or A2 or A1-15”</i> <i>ABYC H33</i></p>	<p>(1) Recommend installing a fuel shut off valve at the fuel tank. (2) Recommend replacing the fuel supply hose from the water separator to the engine.</p>
<p>B8 (1) The batteries are not contained in acid resistant boxes (2) Battery terminals are not covered to protect from accidental contact with ground (3) Burnt battery switch and wiring behind the 12-volt DC panel</p>	<p>(1/2) Install batteries in boxes with covers and secure from movement. (3) Replace battery switch, repair all burnt wiring, clean and or replace all connections and terminals on the 12-volt DC panel. Verify all systems are operable.</p>

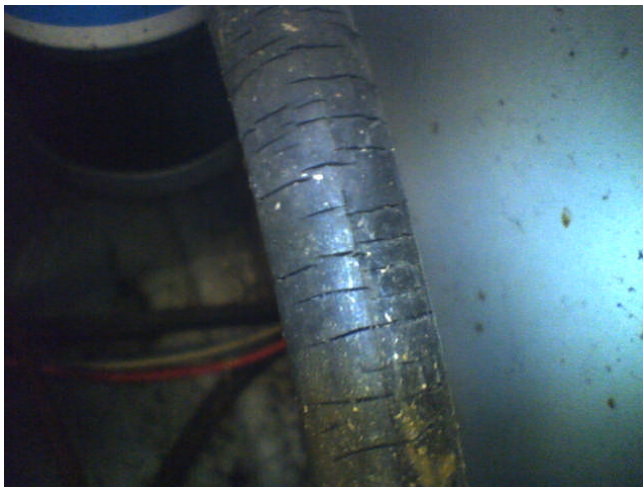
- (1) No fuel shut off valve was seen at the fuel tank
- (2) Fuel supply hose from the water separator to the engine is deteriorated

B7 fuel supply hose deteriorated

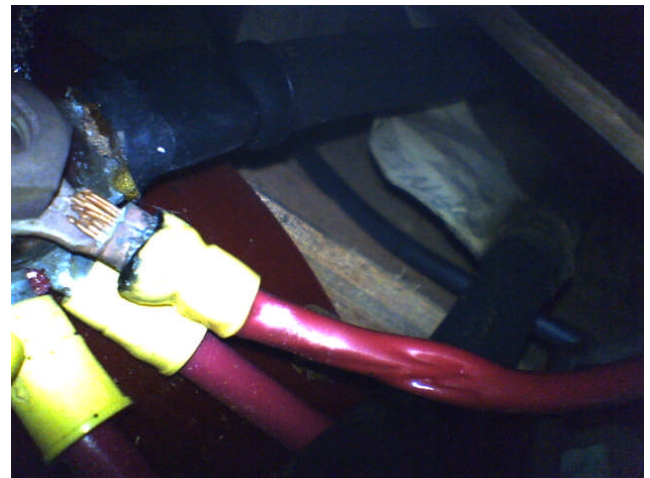
- (1) The batteries are not contained in acid resistant boxes
- (2) Battery terminals are not covered to protect from accidental contact with ground
- (3) Burnt battery switch and wiring behind the 12-volt DC panel

B8/3 burnt wiring behind the 12-volt DC

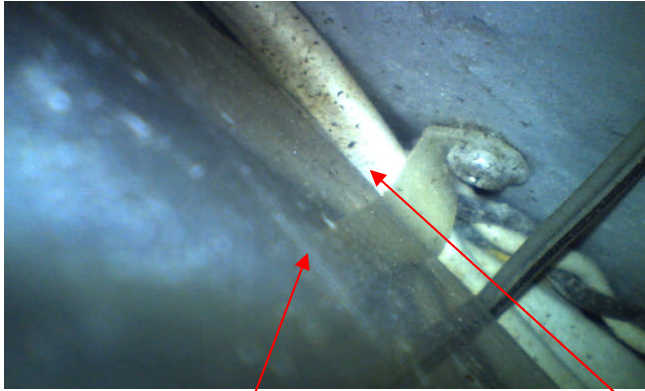
- (1) Under the forward end of the port side aluminum water tank are pinched 120-volt AC wires
- (2) Receptacle in the head may not be GFCI protected

B9/1 water tank 120-volt AC wiring

<p>B9 (1) Under the forward end of the port side aluminum water tank are pinched 120-volt AC wires (2) Receptacle in the head may not be GFCI protected</p>	<p>(1) Re-locate 120-volt AC wiring in this location and install self-draining loom where required. (2) When shore power is available, verify whether or not the receptacle at the head is protected by GFCI’s located elsewhere in the vessel. If not, install a GFCI receptacle in the head.</p>
<p>C1 Port side locker hatch hinge is loose</p>	<p>Inspect and repair.</p>
<p>C2 (1) Fuel fill and vent hoses could not be inspected without the removal of fixed panels (2) Fuel fill and fuel tank grounds were not measured</p>	<p>(1) Recommended removal of fixed panels to inspect type and condition of fuel fill and vent hoses. (2) When the 12-volt DC system is repaired, verify that the fuel fill deck fitting and fuel tank are grounded to the vessels 12-volt DC ground.</p>
