Sample Sail boat Insurance Survey sample
1988 C&C 35 sail boat in winter trim

Prepared for xxxxx

Pre-purchase – Insurance
Marine Surveys

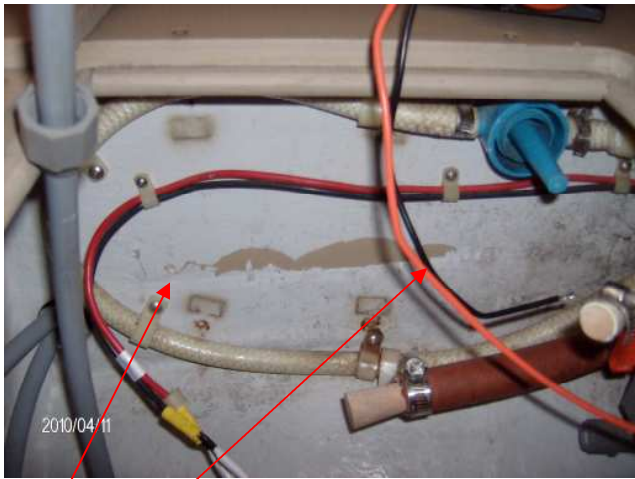
Under the port side settee, forward end, is a tabbing failure approx. 12" long

B1 tabbing failure here to here

| FINDINGS | RECOMMENDATIONS |
|---|--|
| B1 Under the port side settee, forward end, is a tabbing failure approx. 12" long | Grind, inspect, rebuild and refinish gel coat. |

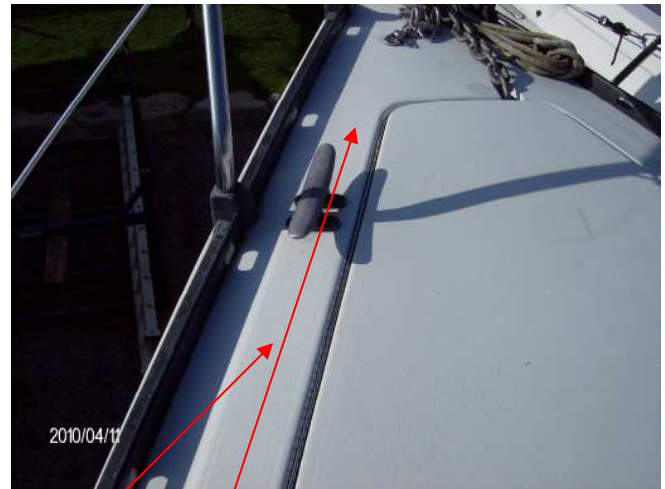
(1) Elevated moisture meter readings where tested at random suggest water intrusion. Percussive soundings where tested at random suggest delamination at;

Port side of the anchor locker hatch (hinge side) approx 2" wide by 24" long.

B2 Elevated moisture meter readings where tested at random suggest water intrusion.

| FINDINGS | RECOMMENDATIONS |
|---|--|
| B2 (1) Elevated moisture meter readings where tested at random suggest water intrusion. Percussive soundings where tested at random suggest delamination at; Port side of the anchor locker hatch (hinge side) approx 2" wide by 24" long. (2) Starboard side cockpit drain hose is weather deteriorated and needs replacement | (1) Remove cleat, add backing blocks, reseal and mount securely. Remove hatch hinge fasteners, re-bed and install securely to stop any further water intrusion. (2) Replace with marine grade hose. |

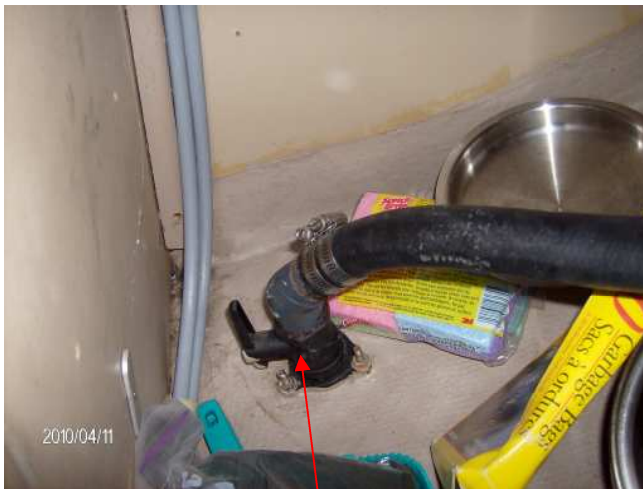
Galley sea cock, fitting between the valve and the hose is loose

B3 fitting loose here

| FINDINGS | RECOMMENDATIONS |
|---|--|
| B3 Galley sea cock, fitting between the valve and the hose is loose | Inspect and repair, check for leaks. |

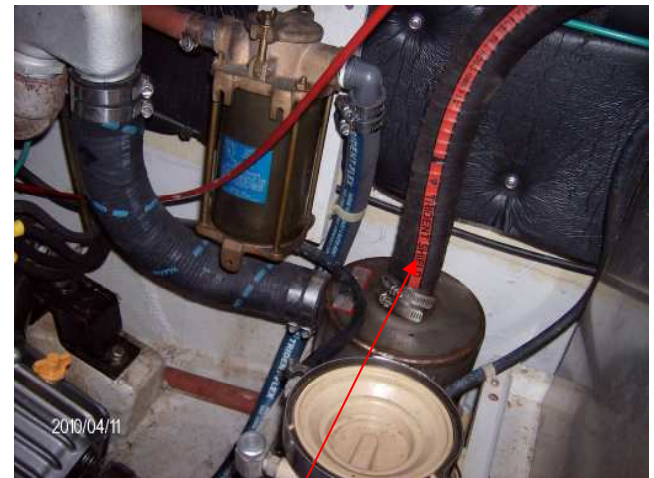
B4 exhaust hose is fuel fill hose not suitable for use as exhaust hose

| FINDINGS | RECOMMENDATIONS |
|---|--|
| B4 Although the exhaust hose from the muffler to the outlet is in good condition, it is non approved fuel fill hose <i>"Hose used in wet exhaust shall be SAE J2006 or UL1129 rated"</i> <i>ABYC P1</i> | Replace exhaust hose with ABYC recommended and double clamp. |

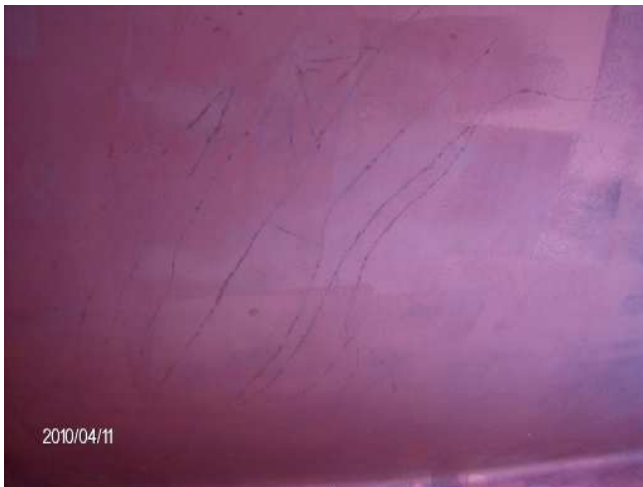
Gel coat crazing could be seen in random areas thru the bottom paint

C1 gel coat crazing on the hull bottom. This area is approx. 12 square inches

| <p>C1 Gel coat crazing could be seen in random areas thru the bottom paint</p> | <p>A small area of the bottom should have the bottom paint and gel coat removed to determine the extent of the crazing. Painting over top or applying epoxy over top may not fill the crazing allowing it to reappear. Grind, inspect, repair, apply epoxy barrier coats and reapply bottom paint.</p> |

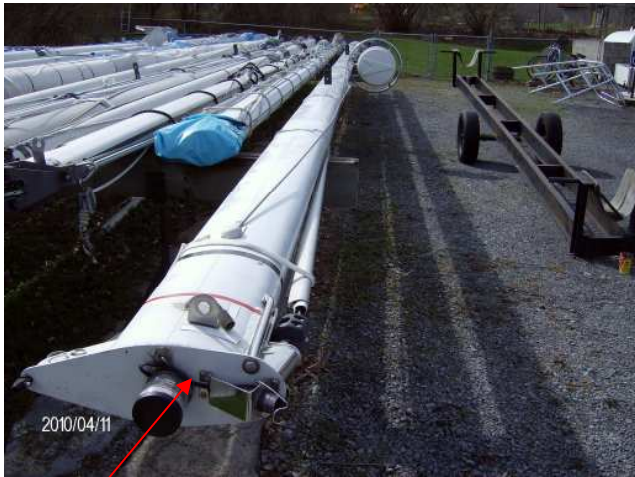
Mast as inspected

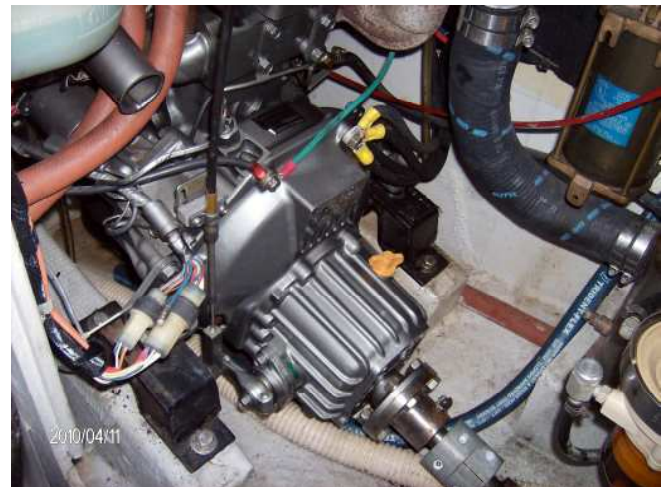
Clean bilge
